GENERAL DYNAMICS ASTRONAUTICS

FLIGHT SUMMARY REPORT SERIES D ATLAS MISSILES

DIVISION REPORT AE60-0131-2

PREPARED BY TEST EVALUATION GROUP

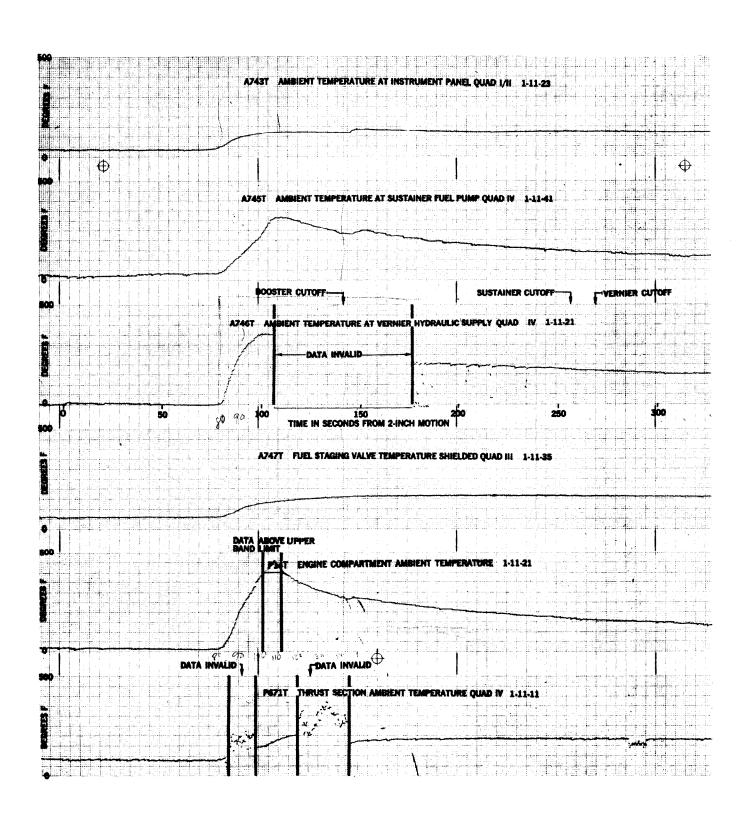
FIGURE 4.3-1 ENGINE COMPARTMENT TEMPERATURE DATA, MISSILE 42D

A vernier hydraulic system failure, which occurred during the flight of D/AIG Missile 42D, was attributed to an abnormal engine compartment temperature environment. The Series D/AIG missiles incorporate a redesigned and enlarged B2 equipment pod to accommodate the

AIG system. A low pressure area in the vicinity of the B2 nacelle was considered responsible for the abnormal temperature increase on this missile. This low pressure area tended to evacuate the engine compartment and apparently caused a large differential pressure to exist across the boots. This created openings (similar to D/RIG missiles) and allowed entry of hot gases into the engine compartment.

Beginning at 80 seconds, engine compartment temperature data indicated an abnormal increase to approximately 400° F at the time of the pressure transient. Thus, it appears that the failure of the GN_2 charge line is partially attributed to an excessively high temperature environment in the engine compartment.

corded on Missile 42D. It should be noted that Missile 42D was the first Series D R&D missile to be flown with the all-inertial guidance (AIG) system aboard. The exterior configuration of D/AIG missiles differred primarily from that of D/RIG missiles in that the B2 equipment pod was redesigned and enlarged to accommodate the all-inertial guidance system. Figure 4.3-2 illustrates the location of this redesigned pod on a Series D missile. It was felt that the redesigned B2 equipment pod caused a low pressure area to form in the vicinity of the B2 nacelle doors, thereby tending to evacuate the engine compartment, causing a large differential pressure to exist across the boots. This pressure differential displaced the boots, and permitted hot exhaust gases to enter the engine compartment.

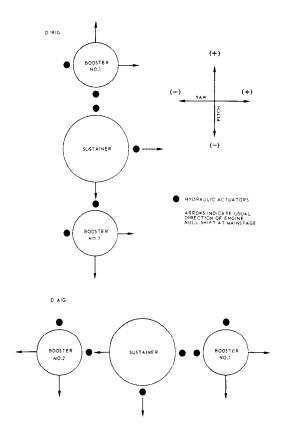
FIGURE 6.1-5 DIRECTION OF ENGINE NULL SHIFTS AT MAINSTAGE

Engine position null shifts and transients at mainstage were negligible. Booster and sustainer null shifts, as measured from telemetered engine position data, were within the allowable 0.6 degrees. A summary of engine position null shifts at mainstage is shown in Table 6.1-3. The null shifts continued to indicate the same polarity pattern as has been observed on all Atlas missiles beginning with the A series. This shift is predominantly in a direction away from the appropriate hydraulic actuator, and is caused by application of the engine thrust vector about the moment arm of the thrust chamber actuator outrigger (see Figure 6.1-5). The D/RIG sustainer yaw engine position and the corresponding D/AIG sustainer pitch engine position, however, often shift in the direction of the actuator.

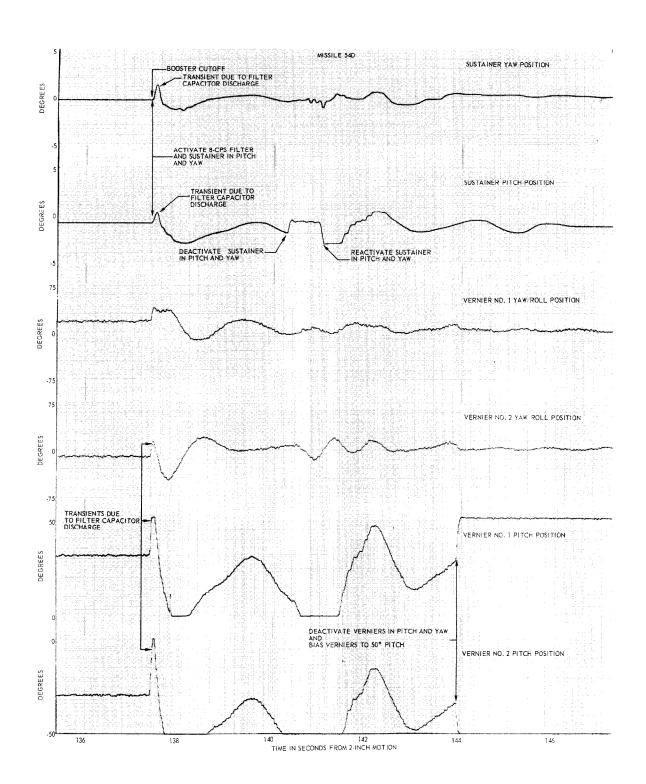
FIGURE 6.1-12 MISSILE 54D ENGINE POSITION DATA AT BOOSTER CUTOFF

A malfunction of the "square" type electronic flight programmer on 54D resulted in failure of the retrorockets to fire at vernier cutoff plus 17 seconds, as required. The programmer malfunction was attributed to ringing of the 28 vdc programmer filter, which subsequently caused the programmer to advance from subroutine 3 (during which time the retrorockets are fired) to subroutine 1, thus bypassing the "fire retrorockets" function. Redesign of the 28 vdc programmer filter successfully prevented recurrence of this problem on subsequent Series D/AIG flights.

On Mercury boosters 77D and on, which will incorporate "square" type autopilots, a 2.2 megohm resistor will be added in parallel with the transistors that effect the filter change. This will limit the charge buildup on the associated filter capacitors to a fraction of the switching control voltage, and eliminate or significantly reduce the engine transients.

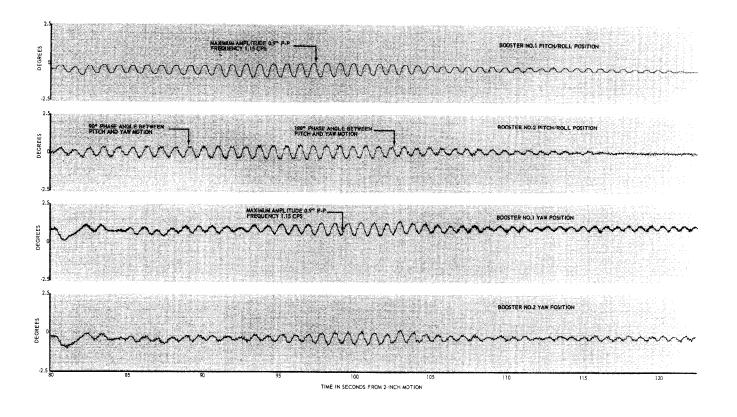
FIGURE 6.1-15 CHARACTERISTIC BOOSTER ENGINE MOVEMENT DURING SLOSH PERIOD

Figure 6.1-15 shows a representative example of the booster engine movements that occurred during the flight of Missile 42D as a result of propellant slosh. It may be seen that the phase angle between the pitch and yaw engine position traces gradually shifts. This indicates that the plane of oscillation of the equivalent lox pendulum* is slowly rotating.

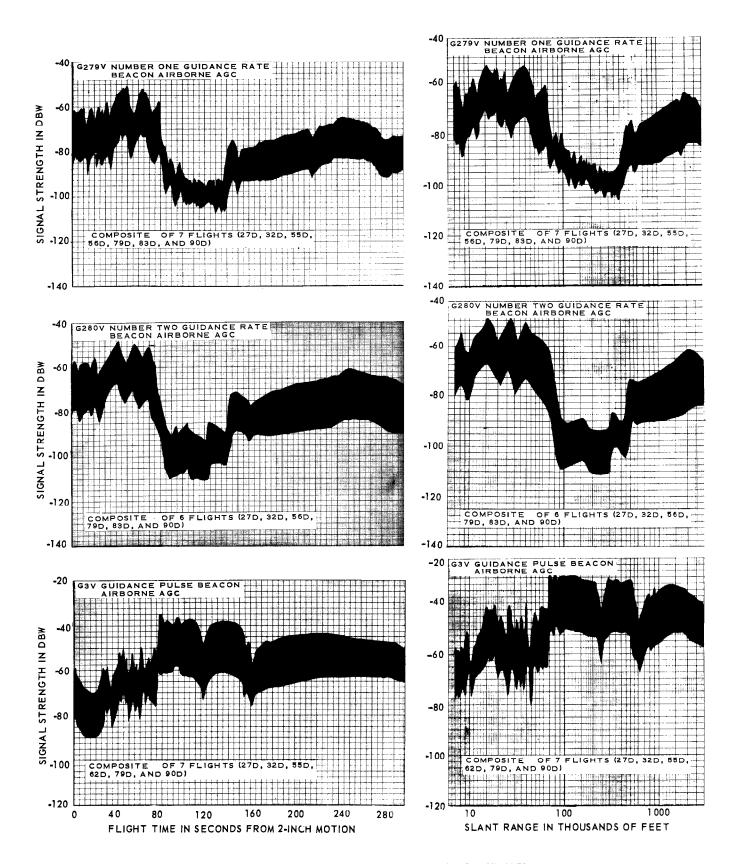
FIGURE 6.2-1 GUIDANCE SYSTEM SIGNAL STRENGTH

The agc signal strengths associated with the Number 1 and Number 2 guidance rate beacons and the guidance pulse beacon are shown in Figure 6.2-1 as a function of time and slant range. These signal strengths showed adequate values for the reception of discrete and steering commands on each radio-inertially guided flight.

The data shows that no excessive dropouts of signals occurred during the guided portion of powered flight (from BECO to VECO). Small signal dropout due to wave attenuation, as on earlier Series C and D Atlas flights, was recorded during the first stage of powered flight (from launch to BECO).

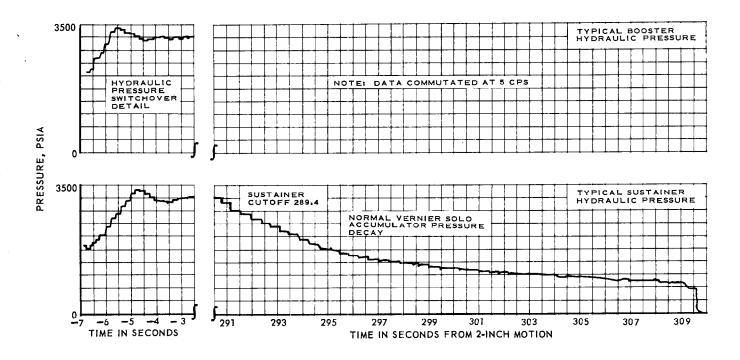
FIGURE 7.1-2 VERNIER SOLO HYDRAULIC ACCUMULATOR PRESSURE

With the exception of 42D, performance of the vernier solo accumulator system was satisfactory. Adequate hydraulic pressure was provided above 680 psig as shown in Figure 7.1-2, for an average duration of 25.7 seconds (42.6 seconds during the flight of Missile 55D).

The sharp decrease in sustainer/vernier supply pressure noted during the flight of Missile 42D, indicated a complete loss of vernier solo accumulator pressure at sustainer cutoff. Figure 7.1-3 shows a typical vernier solo hydraulic supply installation.

The rate of pressure build-up at engine start indicated that the system was functioning properly. A short-duration heavy fluid demand period was indicated at 97.2 seconds by an unusual pressure transient of 300 psig. Subsequent investigation revealed that a pressure transient of this type could be closely simulated by abruptly venting the accumulator GN_2 charge line to atmosphere. It is therefore assumed that, at 97.2 seconds, the aluminum GN_2 charge line (as shown in Figure 7.1-3) ruptured, venting the 3,000 psig GN_2 pressure and causing subsequent loss of accumulator pressure.

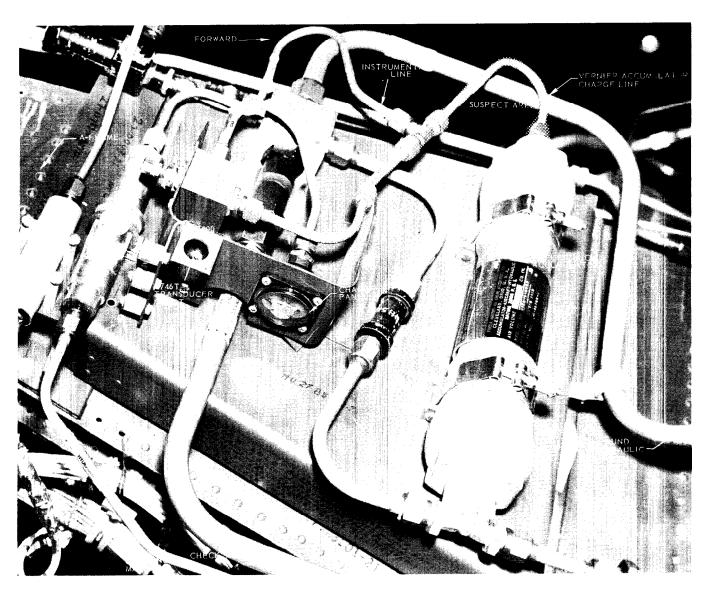
FIGURE 7.1-3 INSTALLATION OF THE VERNIER SOLO HYDRAULIC ACCUMULATOR

The exact reason for this line failure is unknown, but several contributing factors have been isolated. One of these is the abnormal engine compartment temperature increase noted at 80 seconds during the Missile 42D flight. At the time of the assumed charging line failure, data indicated that the temperature in the vicinity of that line reached 370°F.

Laboratory tests were subsequently performed on the GN_2 charging line assembly. This type assembly was pressurized to 3,000 psig and subjected to temperatures between 400 and $600^{\circ}F$. Of the resultant failures, only one was similar in manner to that which is assumed to have occurred on Missile 42D. This failure occurred when an assembly was subjected to a $400^{\circ}F$ environment for a period of 30 seconds. However, further investigation of the failed item revealed that a faulty connection between the charge line and the accumulator flared coupling had contributed to the failure. Other assemblies developed only minor leaks after being subjected to temperatures between 500 and $600^{\circ}F$ for period of 1 to 3 minutes.

These results indicate that tube damage during production and/or installation deficiencies in combination with environmental conditions must be considered as probable causes of a failure of this nature.

The vernier solo accumulator installation, Figure 7.1-3, is now scheduled for all future flight missiles. Certain special space boosters will utilize a 50 cubic-inch capacity vernier solo accumulator unit (either two 25 cubic-inch units or one 50 cubic-inch unit) to provide additional vernier solo pressurization.

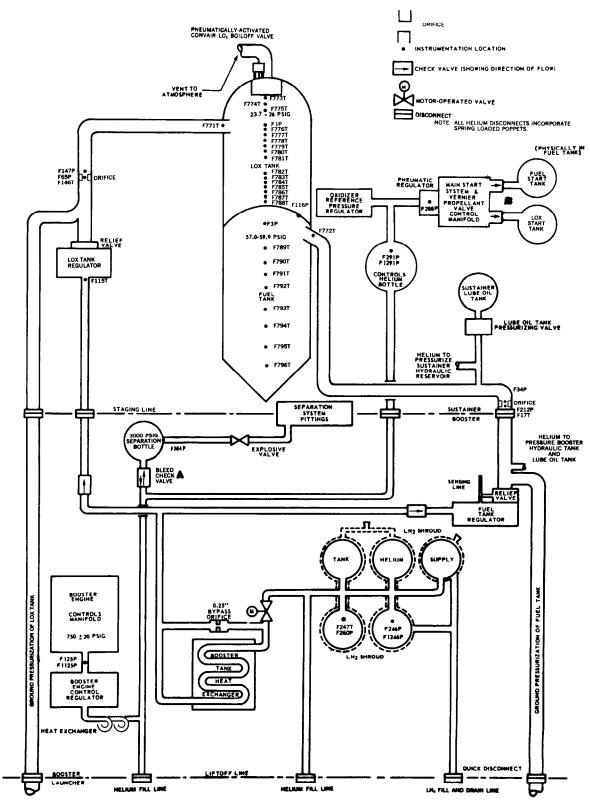
FIGURE 7.2-1 SERIES D PNEUMATIC SYSTEM

Another possible cause of this anomaly is a malfunction of the vernier solo lox tank helium checkvalve in the ISS manifold identified for the purposes of this discussion as checkvalve "B" in Figures 7.2-1 and 7.2-4. A malfunctioning of this valve would permit pressure in the ISS manifold to build up to the level in the vernier solo lox tank. This pressure buildup

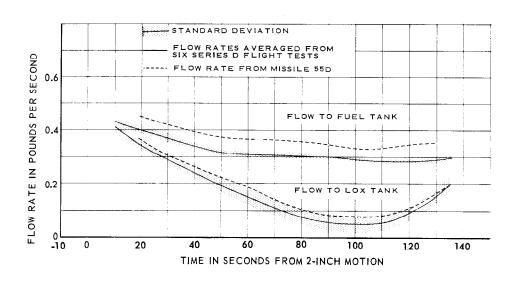
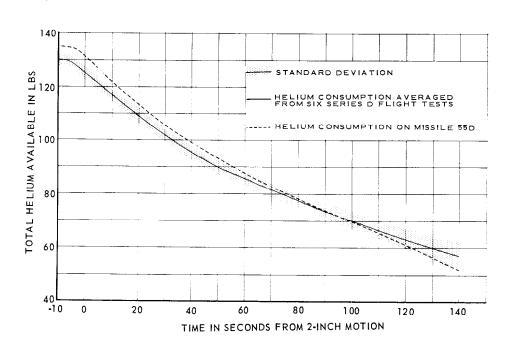
FIGURE 7.2-2 COMPARISON OF PROPELLANT TANKS HELIUM REQUIREMENTS

With the removal of the insulation bulkhead on Missile 55D it was expected that an increase in heat transfer across the intermediate bulkhead would chill the fuel tank ullage space and significantly increase the amount of helium required to maintain proper tank pressure. A graph of helium requirements for Missile 55D propellant tank pressurization is presented in Figure 7.2-2. Also shown are data from previous Series D flights, included for comparison. From Figure 7.2-2, it is evident that the helium requirements on Missile 55D were greater than normal, but not excessive. Total helium used during the booster phase of flight, calculated from the time history of pressure, temperature and volume data in the five helium storage bottles, was found to be 79.8 lbs or 12% greater than the average 71 lbs required on previous Series D flights. Refer to Figure 7.2-3. Approximately 55 lbs of usable helium, or 42% of the total available at liftoff, remained at booster cutoff. At staging, this helium along with all tank pressurization system hardware, with the exception of the lox tank regulator, was jettisoned along with the booster thrust section.

Calibrated orifices were located in the helium supply lines to the propellant tanks for determining helium flow rates. Resulting flow rates to the fuel and lox tanks calculated from recovered data indicated that helium flow to the fuel tank was significantly greater on Missile 55D than the average noted on six previous Series D flights. Refer to Figure 7.2-2. Approximately 10 to 15% more helium was required for fuel tank pressurization during booster stage, most of which was assumed to be the result of removal of the insulation bulkhead.

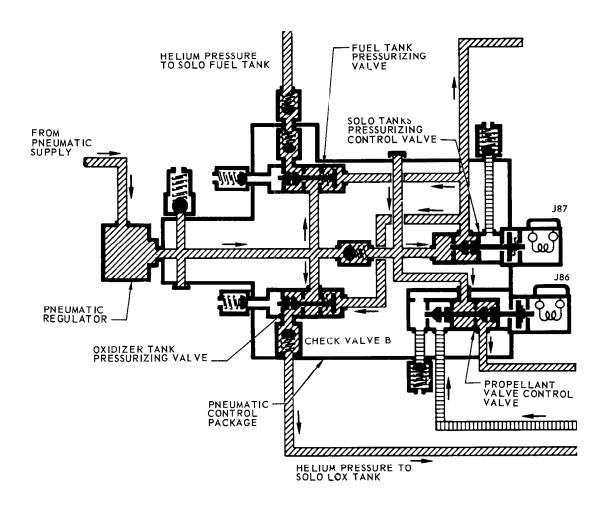
FIGURE 7.2-4 INTEGRATED START SYSTEM MANIFOLD

The integrated start system (ISS) pneumatic regulator did not perform as expected after vernier engine tanks repressurization on six flights. (Missiles 56D, 62D, 32D, 66D, 79D, and 83D.) Regulator discharge pressure failed to return to the proper level after the normal overpressurization transient and exhibited a gradual increase to a pressure of approximately 700 psig. The pressure remained at this level until sustainer cutoff when it abruptly returned to its nominal level of 600 psig. There were no apparent detrimental effects. This anomaly is assumed to be either the result of a piston O-ring modification incorporated in the regulator by Rocketdyne or a malfunctioning of the vernier solo oxidizer tank helium check valve in the ISS manifold. The new O-ring, having tighter dimensions and tolerances, could bind against the cylinder wall causing the piston to stick and to move erratically, thereby causing the pressure buildup condition. A malfunctioning check valve could permit vernier lox tank pressure (approximately 670 psig) to be reflected at the discharge side of the ISS pneumatic regulator. At the time of this writing, neither possibility can be firmly established as the cause of this anomaly. Investigation of this problem is being continued.

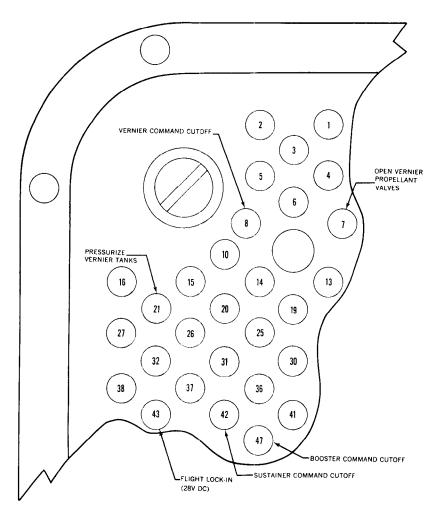
FIGURE 7.3-2 60013 UMBILICAL RECEPTACLE

During the booster phase of the Missile 60D flight, difficulties with the missileborne electrical system caused repeated pressurization and venting of the vernier engine tanks, resulting in depletion of the controls bottle helium supply and subsequent abnormal operation of both the sustainer and vernier engines. This was not considered to reflect on the adequacy of the pneumatic system.

After detailed review of the events which occurred during ground checkout and flight and thorough analysis of the system circuitry, it was determined that an electrical short circuit between the PVT relay (K32C) and the vernier propellant valves control relay (K44C) would cause a malfunction of the type which occurred during the flight. However, the reason for the existence of this short could not be established from the data available.

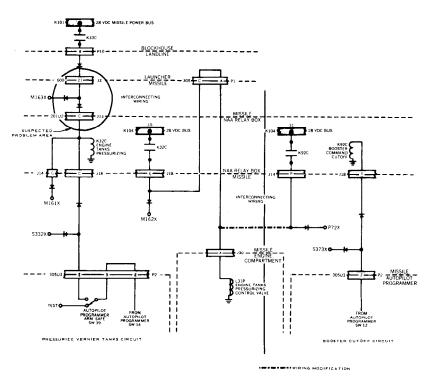
FIGURE 7.3-3 PRESSURIZE VERNIER TANKS CIRCUITRY, SHOWING SUSPECT PROBLEM AREA

On Missiles 66D, 71D and 76D, additional instrumentation was added to monitor the vernier tanks pressurization circuitry and the booster cutoff circuitry. The electrical circuitry, on all missiles subsequent to 60D, was modified in that the PVT sequence was initiated by the booster cutoff relay (K92C) at booster cutoff rather than the programmed PVT relay (K32C) at 165 seconds (BCO plus 64 seconds on vehicles utilizing the square autopilot). The programmed PVT relay sequence was operated open-loop to monitor spurious signals, short circuits or other anomalies. Figure 7.3-3 shows this modified circuitry and location of the additional instrumentation.

Results of data obtained during the flight testing of Missiles 66D, 76D and 71D, indicated normal operation of relays K32C and K92C. No recurrence of the 60D problem has been evidenced on any subsequent Atlas flight.

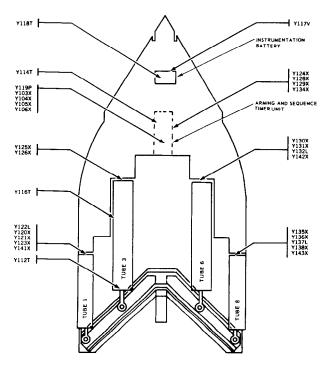
FIGURE 8.2-1 RESEARCH AND DEVELOPMENT FOUR TUBE DECOY POD

A decoy pod was flown on four of the missiles included in the scope of this report. Missiles 55D, 62D and 83D carried the 4-tube version of the R&D pod as shown in Figure 8.2-1. Launch tubes 1, 3, 6 and 8 were installed, each containing decoys planned for ejection. Tubes 1 and 8 each contained a prototype nosecone balloon and tubes 3 and 6, a graphite dart with arms. Missile 90D carried the Mod I pod shown in Figure 8.2-2 which carried a single launch tube containing a ring-augmented dart.

Laboratory tests conducted after the flight indicated that the failure of tubes 1 and 8 was probably due to an interference with the proper action of the pin puller which unlatches the launch tube. Design modifications were effected to prevent a recurrence of the failure.

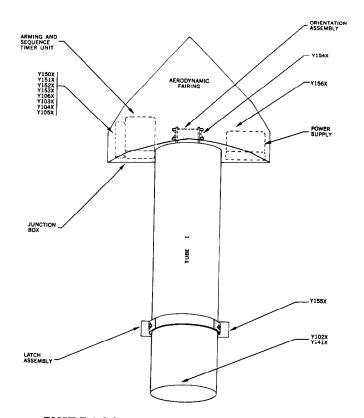
FIGURE 8.2-2 MOD I SINGLE TUBE DECOY POD

Operation of the arming and timing unit was satisfactory; however, the telemetry data indicated that the single launch tube did not orient properly and the decoy canister was not ejected. Post-test investigation revealed a possible malfunction of the launch tube latch assembly, resulting in failure to orient the tube properly. Failure to eject the decoy canister was attributed to an open circuit between the timing unit and the ejection mechanism.
